## DREDGED MATERIAL RESEARCH PROGRAM

MISCELLANEOUS PAPER D-78-3

PERIMETER DIKE RAISING WITH DEWATERED  
FINE-GRAINED DREDGED MATERIAL AT  
UPPER POLECAT BAY DISPOSAL AREA  
MOBILE, ALABAMA

11 Aug 1978

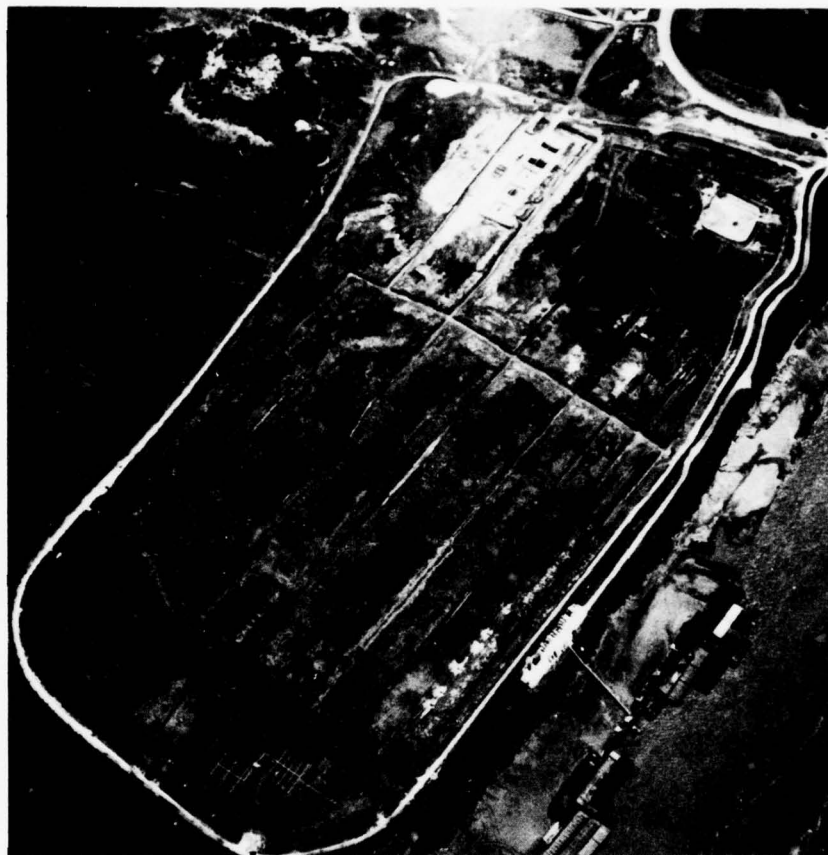
Figure 2. Aerial view of Upper Polecat Bay Disposal Area prior to initiation of dike-raising activities. Note the surface drainage network produced by DMRP DOP dewatering field demonstrations. North toward the lower left corner of the photograph

69. As shown in Figures 2 and 5, the southeast portion of the disposal area, where the dredge inlet pipe was normally placed, had been covered with a large sand mound. A DOP underdrainage study described elsewhere<sup>5</sup> was still in progress in this area. Construction of underdrainage test pits had raised elevations in this portion of the site to approximately El. 21 to 23 MSL. The perimeter dike was relocated around this ongoing DOP experiment, the perimeter of the experiment raised to El. 24 MSL, and a short dike segment constructed from the DOP experiment area to the original east dike, located as shown in Figure 5. This dike segment, shown in Figure 22, was constructed up to El. 25 MSL from existing ground elevations in the vicinity of El. 14 to 18 MSL in one lift using essentially uncompacted, coarse-grained material. A small amount of raising around the perimeter of the DOP underdrainage work units was accomplished by the small wide-track dozer. Construction operations in this part of the disposal area proceeded smoothly. As coarse-grained material was

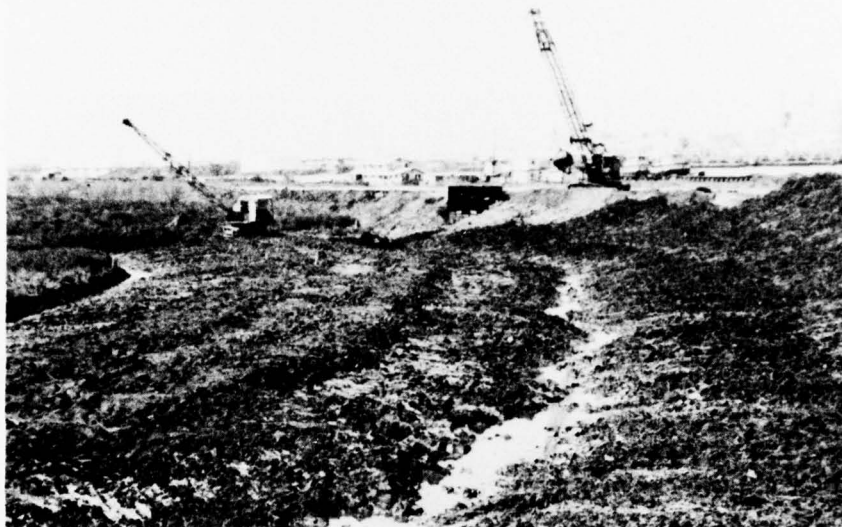
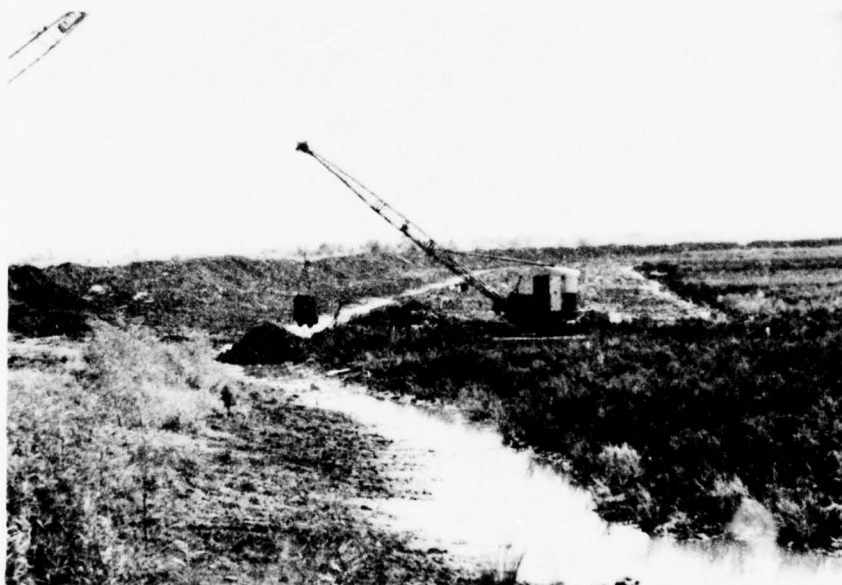
Figure 6. Tandem dragline borrow removal operation

a. Tandem dragline operation removing dewatered fine-grained dredged material. Operation has reached the northmost weir location

b. View of small dragline working on mats inside perimeter dike. Note pile of material placed for large dragline rehandling and drainage ditch maintained after borrow removal

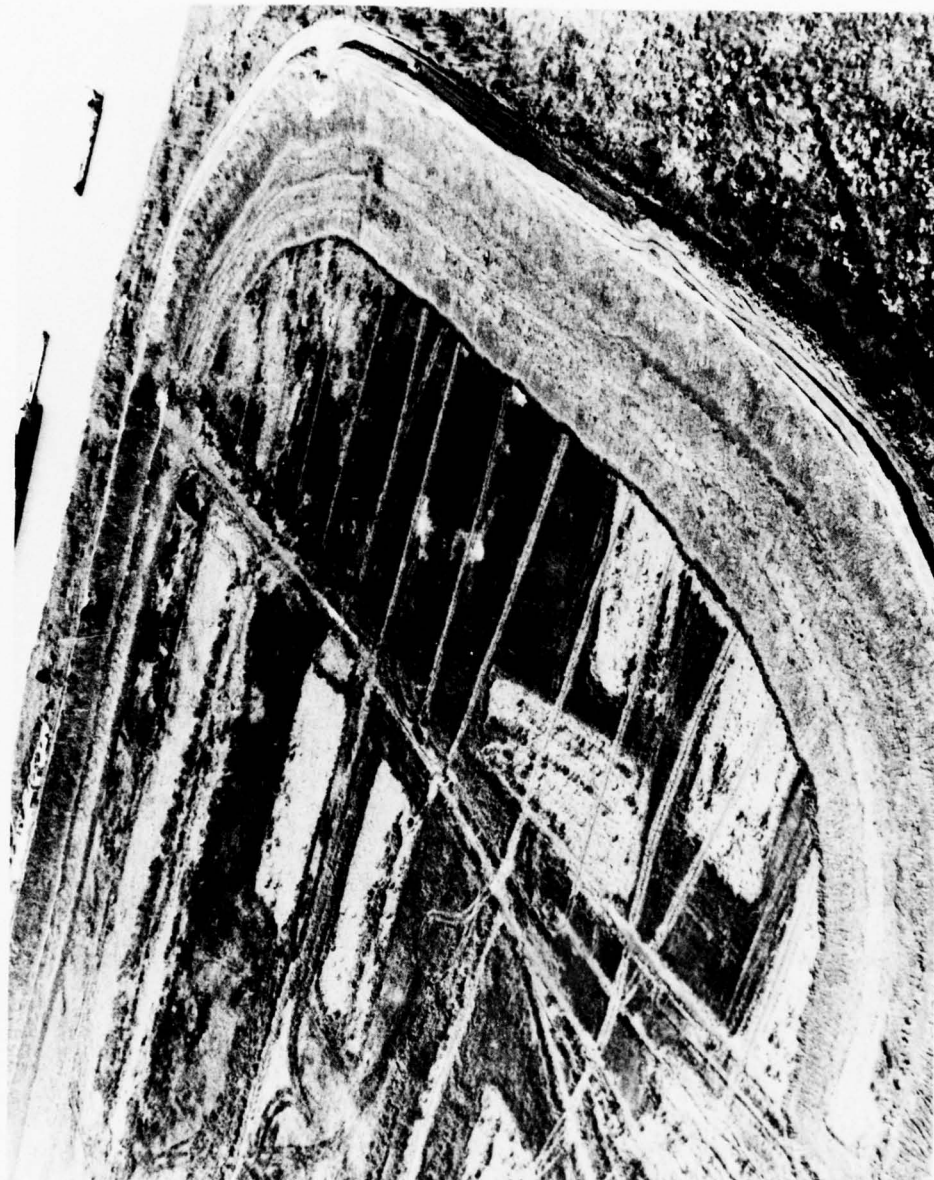
Figure 7. Aerial view of north end of Upper Polecat Bay Disposal Area, looking west southwest from northeast corner. Note strip of dewatered fine-grained dredged material removed around disposal site perimeter

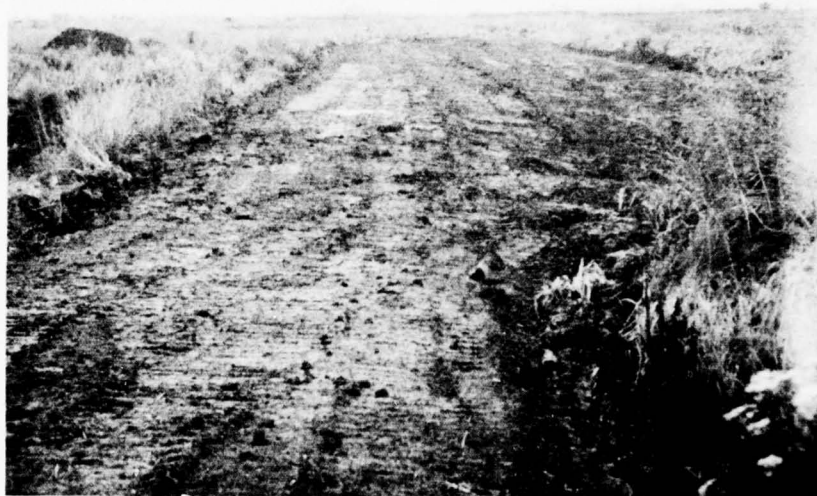
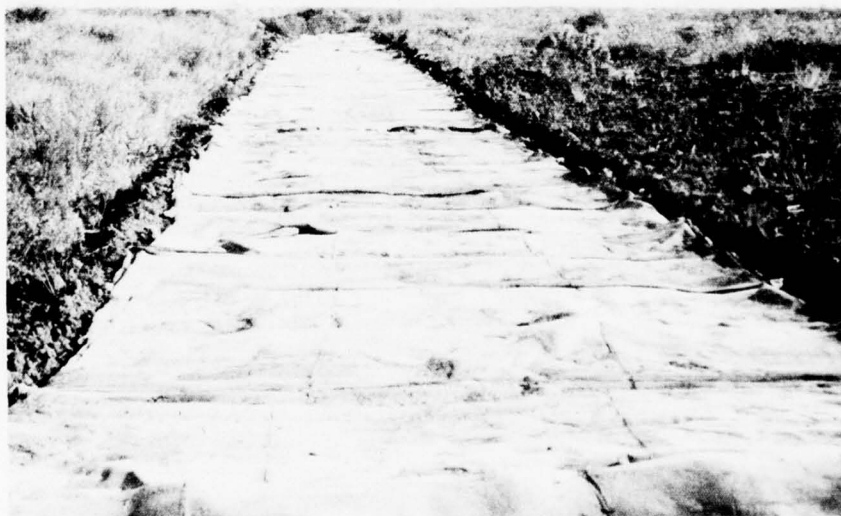
Figure 8. Details of interior haul road construction

a. Mounded subgrade for interior haul roads was constructed with the small wide-track dozer. Material was bladed from the right of the photograph and semicompacted to form the haul road pad shown in the center of the photograph

b. After the pad was complete, 12-ft-square sheets of filter fabric were laid on the pad and overlapped

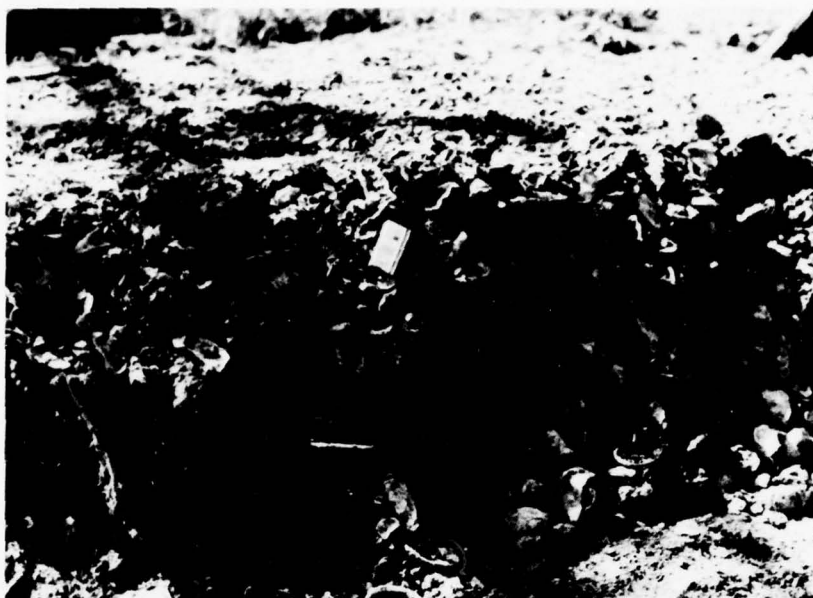
Figure 9. Photograph of completed haul road section showing dredged material surface, semicompacted subgrade mound, and shell surfacing. The fabric was placed at the interface between surfacing and subgrade

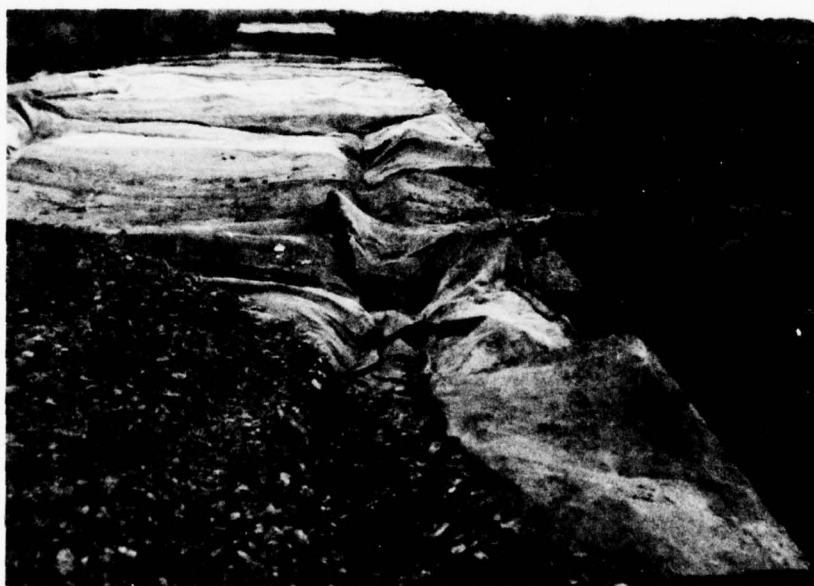
Figure 10. Rutting in the fabric-supported subgrade occurred when trucks backing down the haul road spreading shell continued to back after their load was exhausted. The photograph illustrates the need for fabric cover to obtain desired roadway performance

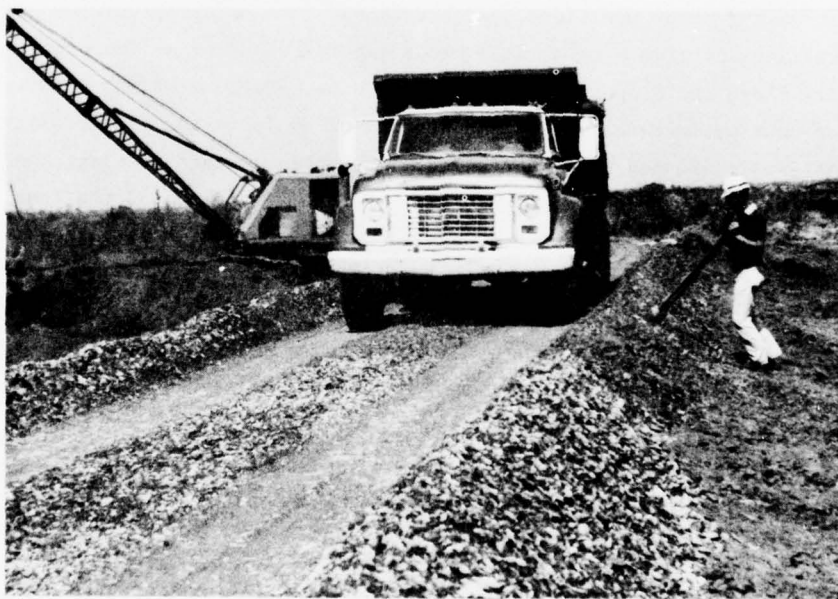
Figure 12. Photograph of spur haul road surface after approximately 300 load repetitions. Note relatively good condition of surface with minimal rutting in wheel paths

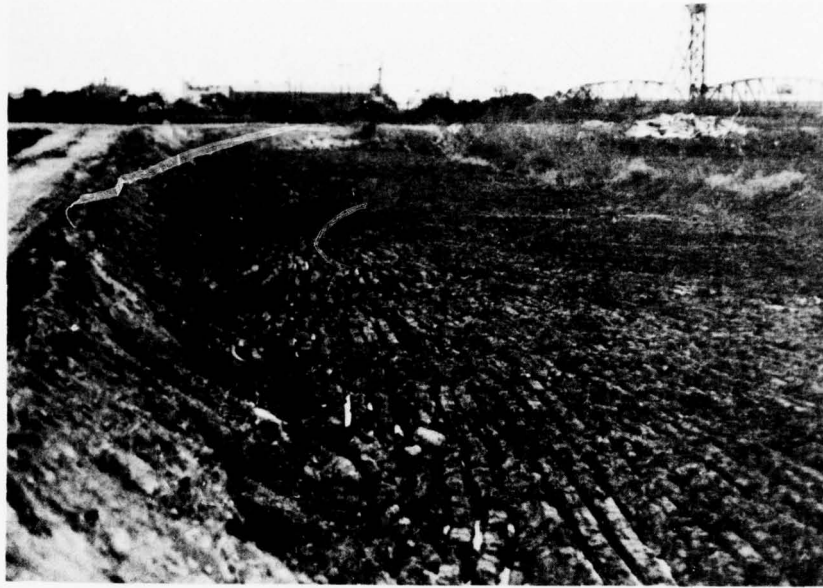
Figure 13. View along edge of spur haul road after dredged material crust had been removed. No evidence of subgrade bulging, foundation bearing failure, or mud waves is seen in the photograph

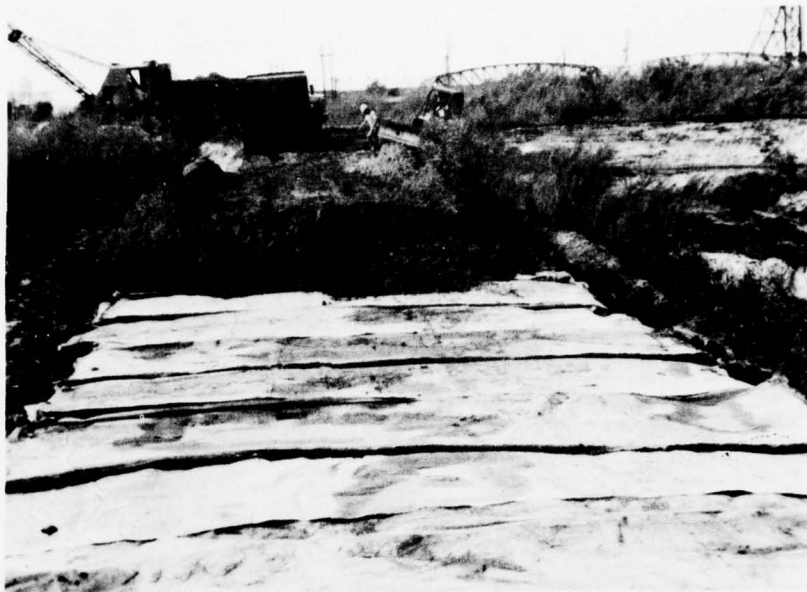
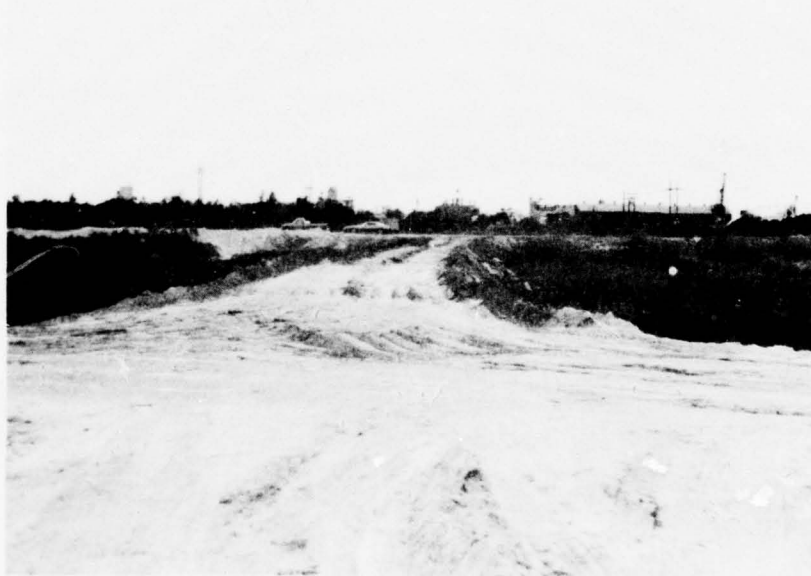
Figure 14. Details of haul road surfacing with cement waste

a. Cement waste evaluated as road surfacing is shown being placed on the fabric-covered subgrade. Note the resemblance of the partially hydrated cement waste to sand

b. Condition of cement waste surface on spur haul road after approximately 400 load repetitions

47. Figure 14a shows the cement waste being placed on the ALCOA-provided filter fabric. Initial attempts at dozer-track compacting this material in a dry state were essentially unsuccessful. Some attempts were made to haul water to the material in the contractor's dump trucks; these attempts were only partially successful. The most successful construction technique for compaction

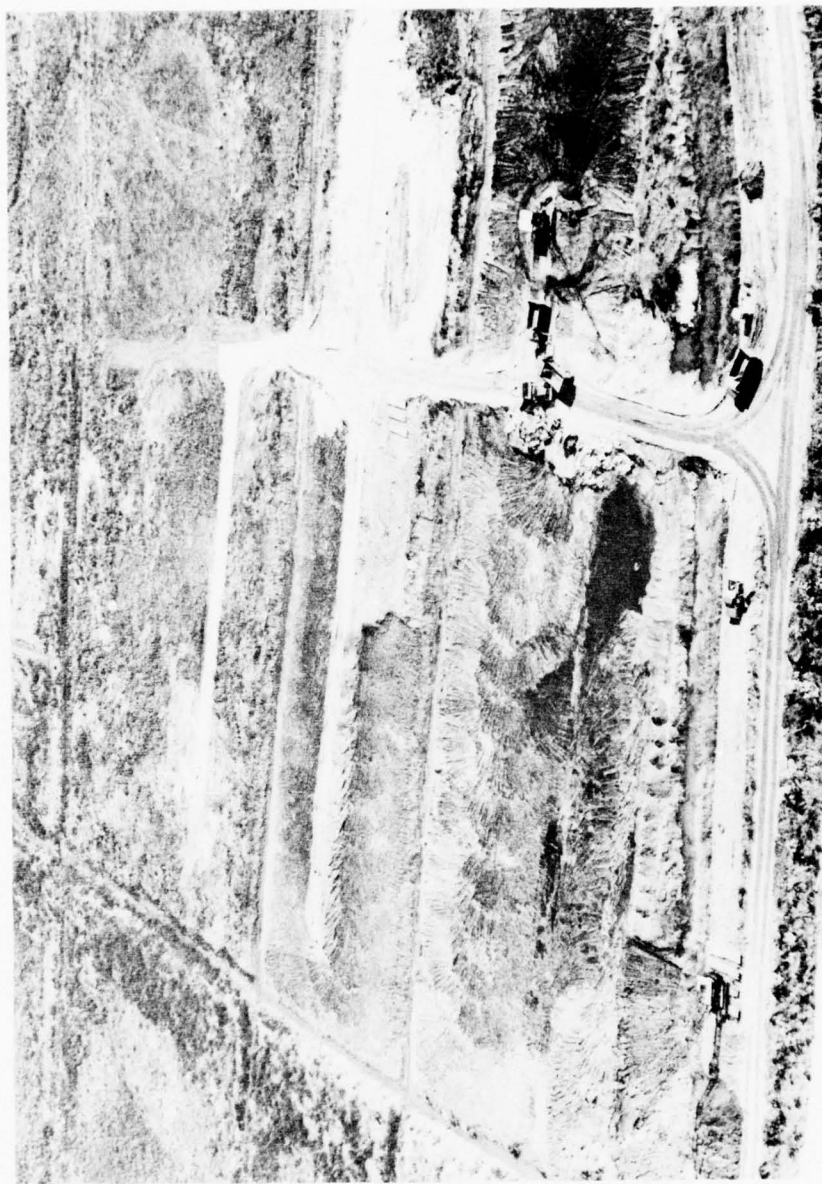
Figure 15. Aerial view of interior borrow area looking east. Note main west-east haul road entering roadway from existing dike crest. The first spur haul road in the left corner of the photograph has already been removed, along with the borrowed crust. Partial borrow operations have been conducted along the second spur haul road and the dragline is currently removing the other arm of the first spur haul road. Also seen in the photograph are a completed haul road spur, not yet in use, in the right center of the photograph and fabric placed for a third haul road spur in the upper center of the photograph. The subgrade pad established for the main haul road may be seen as an extension of the existing main haul road in the upper part of the photo

48. Figure 15 is an aerial view of the haul road area. As may be noted from the photograph, material has been removed from the lower left portion of the photograph and the spur haul road that extended into this area has also been removed. Borrow removal has taken place along one haul road, and another haul road is being removed. An already constructed but not yet used haul road may also be seen in the photograph, as well as fabric placed for another spur haul road.

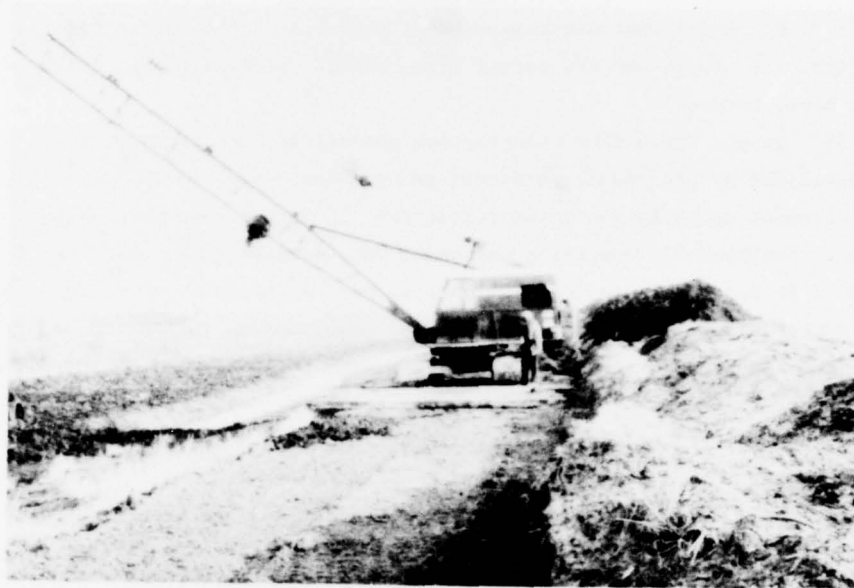
Figure 16. Large dragline shown removing crust from inside perimeter of east dike. Crust bench under dragline mats will be used for construction of second lift. Note mounds of borrow along alignment placed by previous truck haulage from interior borrow area. Small dragline is shown in background placing second lift in long partial segment construction

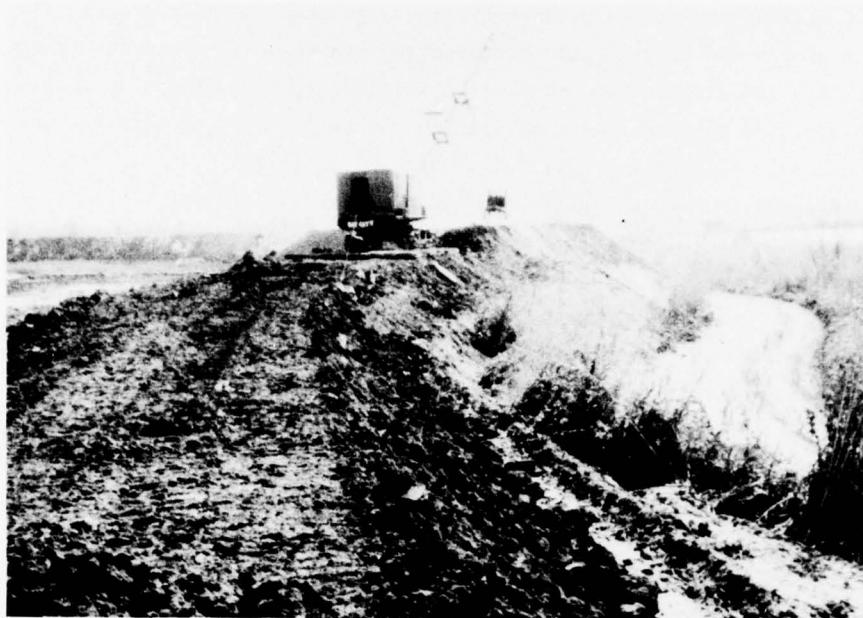
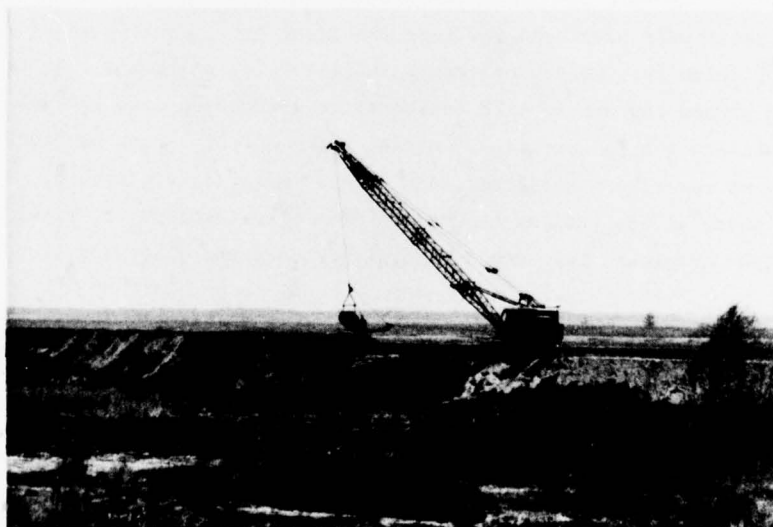
Figure 17. Long partial segment dike construction method

a. Dragline is shown completing first lift along east dike. Borrow in foreground has been roughly shaped by dozer to facilitate precipitation runoff. Ragging on stake in center of photograph indicates El. 20 MSL, crest elevation for first raise lift

b. After initial construction, the second lift was placed and crest and side slopes dressed by the dragline

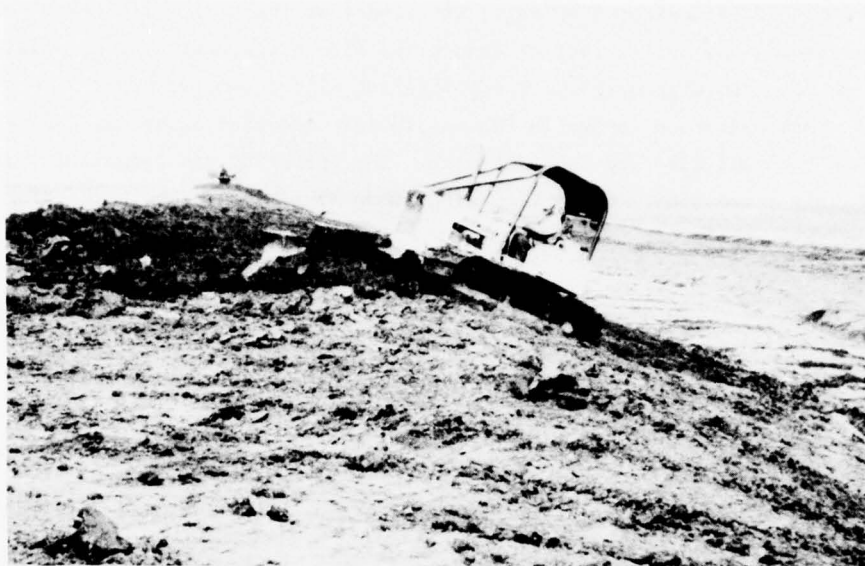
Figure 18. Small wide-track dozer shown constructing first lift while dragline in background of photograph constructs second lift and dresses the crest and side slopes

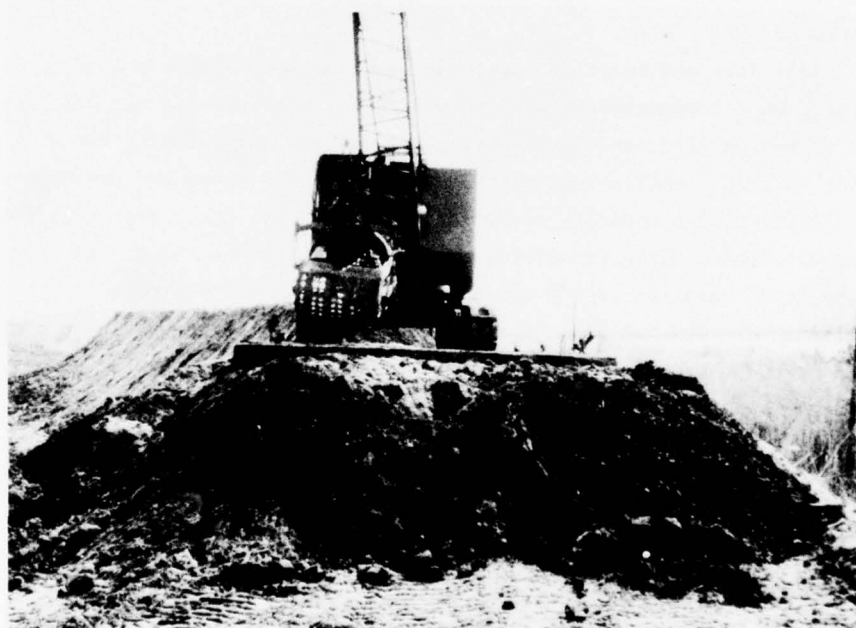
Figure 19. In the sequential dike construction technique, the dragline constructs the first lift ahead for a short distance, then rotates its boom and constructs the second lift behind, while moving down the dike alignment

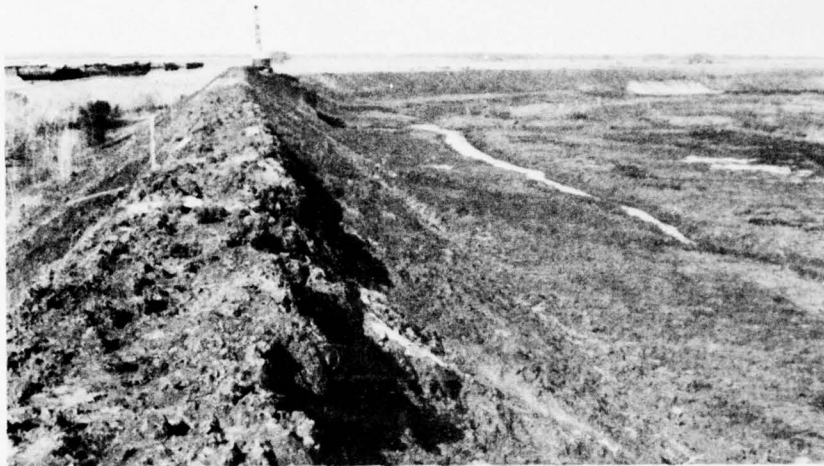
Figure 20. Rain-induced sloughing and sliding of uncompacted second lift. Note rotational slumping on inside slope with crest subsidence. Underlying semicompacted first lift was not affected

a. Sloughing and localized sliding by portions of the newly placed second lift, as a result of 10 in. of precipitation received over 2 days.

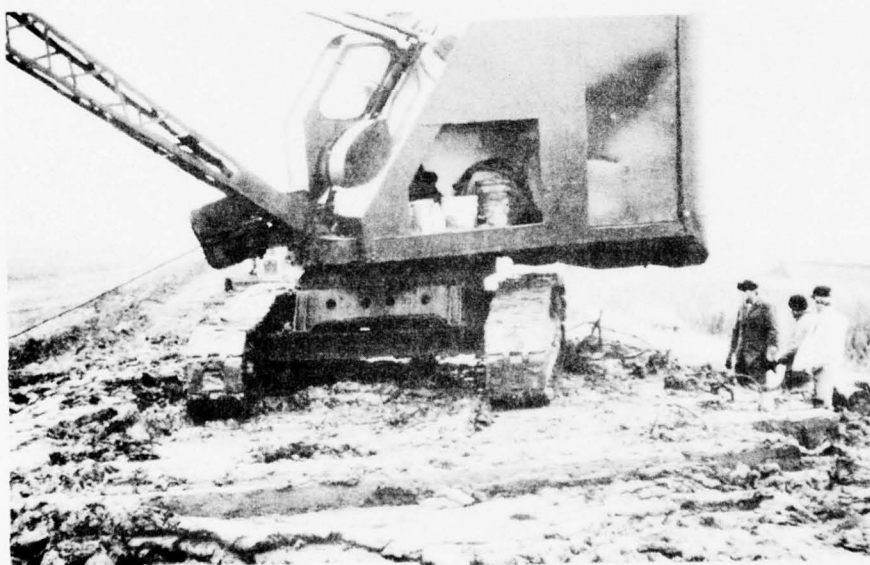
Figure 21. Dragline in mobility trouble on east dike caused from precipitation ponding and infiltration into previously place first lift

b. Insufficient strength and stability of fine-grained dredged material borrow and first lift on part of the west dike as a result of precipitation ponding and infiltration.

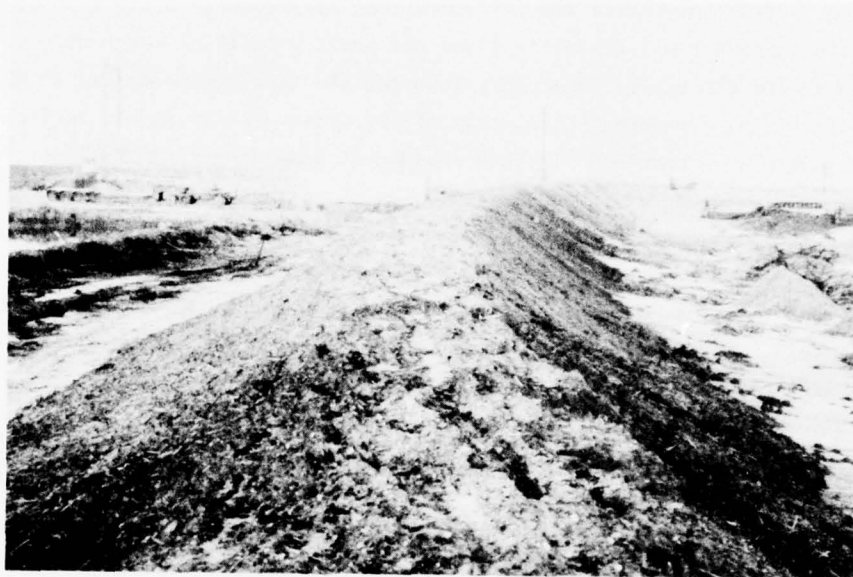
Figure 22. Dike segment of essentially coarse-grained material constructed between east dike and DOP underdrainage experiment location. View looking east from the east dike toward the DOP underdrainage experiment. Note traces of snow on the embankment

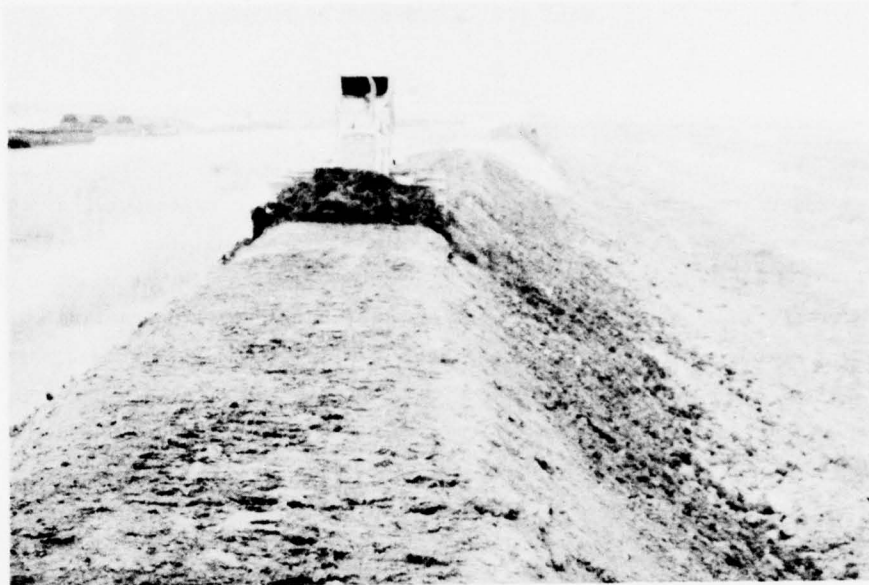
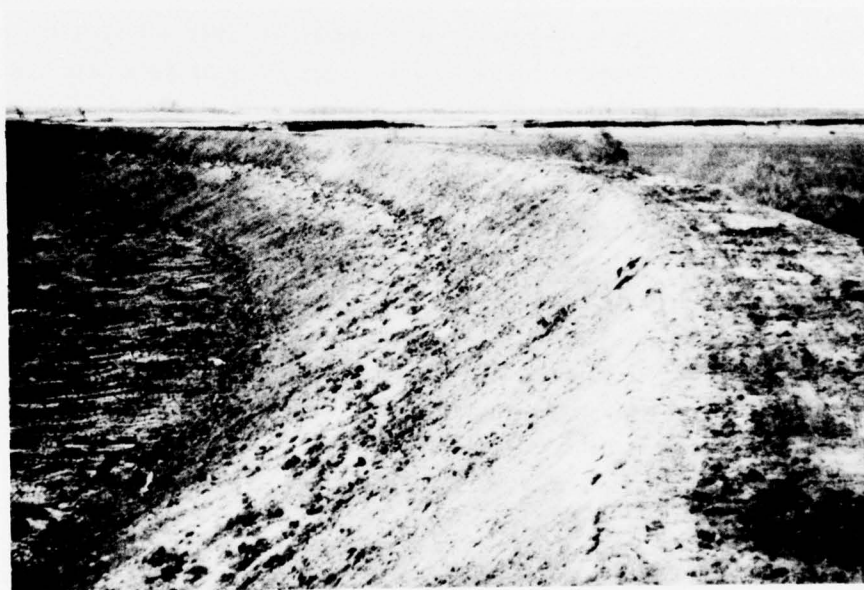
Figure 23. Completion of perimeter dike raising

a. As the last construction operation, the small wide-track dozer bladed the dike to 8-ft crest width at El. 24 MSL

b. View of the completed raised perimeter dike

70. After the entire dike alignment had been raised to El. 25 MSL, the dragline equipment was demobilized and the small wide-track dozer made two passes around the entire perimeter, lowering the final grade to El. 24 MSL while providing some track compaction of the crest. Material bladed from the crest was spilled down the finished embankment side slopes and served to fill in any small erosion gullies. Over most of the alignment, the uncompacted second lift had subsided approximately 6 to 9 in. since construction. Approximately 2 working days were required for the dozer to complete cutting the embankment to El. 24 MSL and shaping the crest to facilitate future precipitation runoff. The dozer operation is shown in Figure 23a and the finished disposal area dike is shown in Figure 23b.
